Case Study

Permanent Tiebacks

Date: August 2001 - August 2002
Job Name: Crockett Interchange Project
Owner: CALTRANS
Location: Crockett, CA
General Contractor: C.C. Myers, Inc.

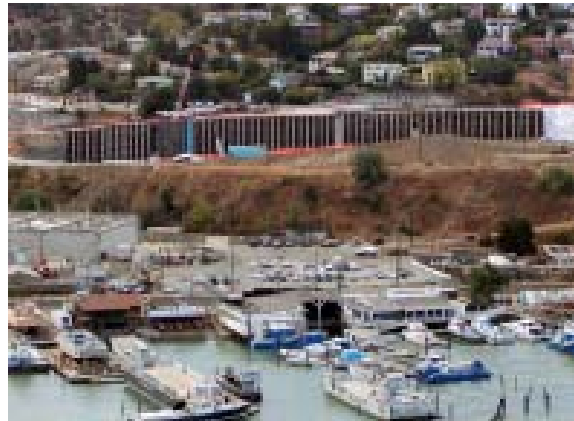
Wall R1 was the largest wall on the site and one of the largest of its kind in the world. Standing nearly 20.5 meters at its tallest point and ranging 168 meters in length, the wall cut a massive face into the existing hillside.

As a result of the unstable soils, variable water table and extreme seismic loads, due to its proximity to the San Andreas Fault, the anchors used in this wall had to be designed to reach far into the hillside and retain sizable loads. Of the 342 anchors 200 were over 30 meters in length with the longest at 40.8 meters. Test loads of these 6 to 8 strand anchors ranged from 1000 to 1500 kN in bonded lengths of 10 to 28 meters. The tiebacks were grouted in five stages. The wall was typical top down construction

with 6 lifts total. The ties were installed through drilled double WF-Section piles. The wall was faced with creosote treated timber lagging.
