Case Study

Permanent Tiedowns

Job Name: Golden Gate Bridge Abutment Tiedown

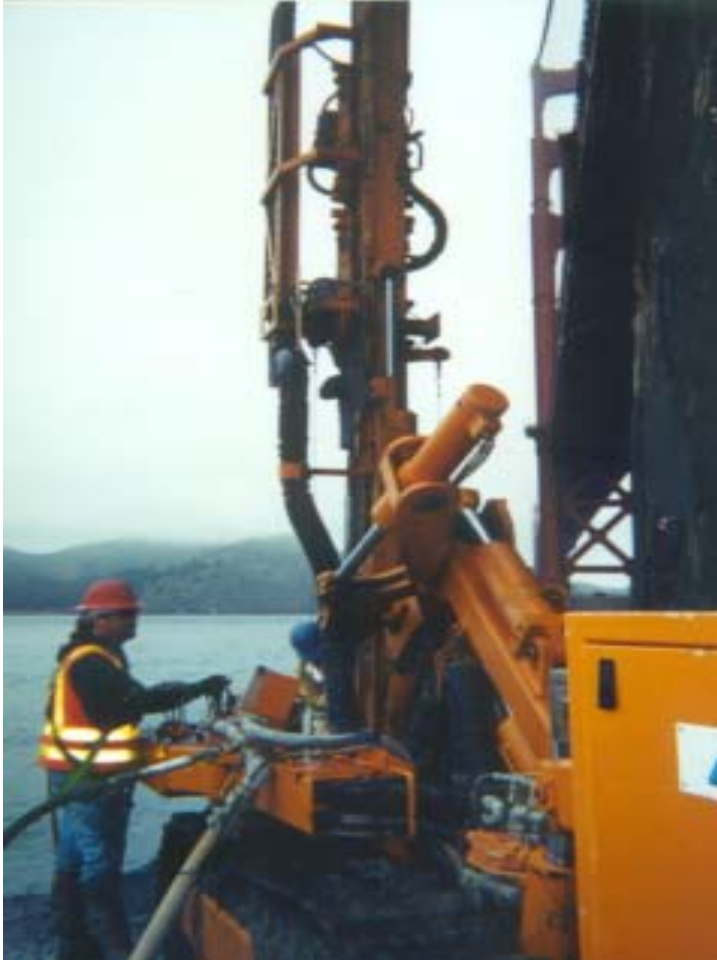
Since the location of the piles was adjacent to the ocean, work could only take place during low tide. This, with extremely narrow access area turned the project into a logistical challenge.

Installation of the tiedowns consisted of drilling through the existing wing walls on the ocean side of the bridge abutment. The tiedowns connected the wing walls to the underlying bedrock so that false work could be constructed upon it and then later a thicker wing wall could be poured. Since the location of the piles was immediately adjacent to the ocean, work could only take place during low tide. This, combined with the extremely narrow access area, turned the installation of comparatively simple tiedowns into a real logistical challenge.
