# Case Study

## Micropiles

**Job Name:** Richmond-San Rafael Bridge Seismic Retrofit

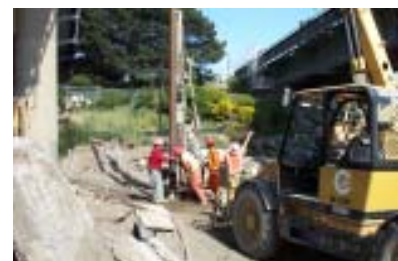
Setting 8 5/8"Ø Steel Reinforcement

The 8 5/8" reinforcing element had to be placed in sections to accommodate the overhead restriction, and all splices were made with full penetration welds. Once the reinforcing was in place the hole was tremie filled with 4000 psi, type I-II cement grout. On both ends of the pile shear rings were welded to the casing to provide greater bond between the pile and the surrounding cement. These shear rings were fabricated off site and welded to the pile in the field.

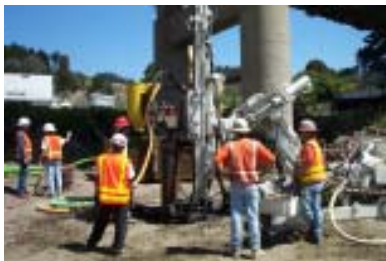
Installation of  
Verification Pile

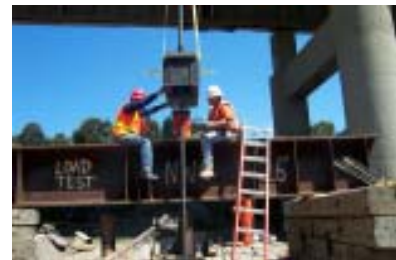
Test Set up for 400 kip  
Tension Test
