Case Study

Emergency Utility Tunnel Replacement After Nisqually 2001 Earthquake

PROJECT: Highline Community College Emergency Tunnel Replacement

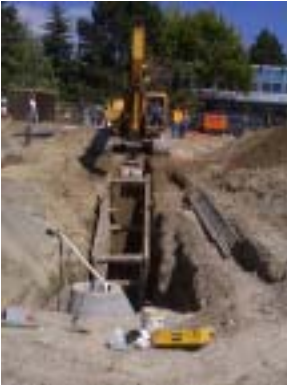
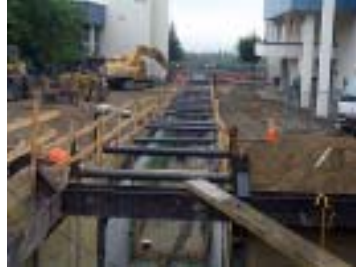
The project consisted of construction of 450' of 15' deep, 9' wide tunnel supported by drilled W6x25 soldier piles and shored with 4" thick timber lagging. The project also included three 20'x18'x12' connection nodes between the tunnel sections, resulting in 3500 SF of shoring wall supported by W14 drilled soldier piles, 6" thick timber lagging, and covered with shotcrete.
